## Green Street Corridor Study May 2016

#### INTRODUCTION

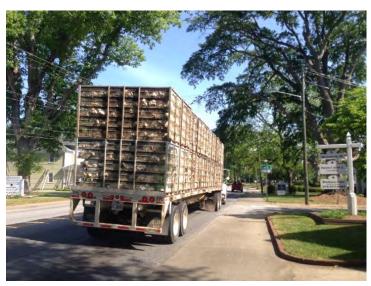
HEAVY TRUCK TRAFFIC IS COMMON ALONG CORRIDOR

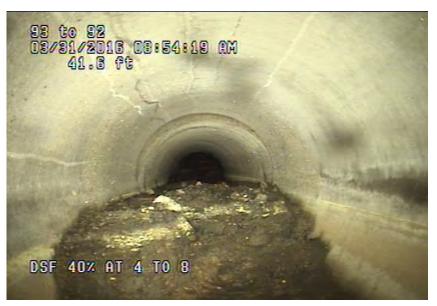
EXAMPLE OF PIPE PARTIALLY BLOCKED BY DEBRIS

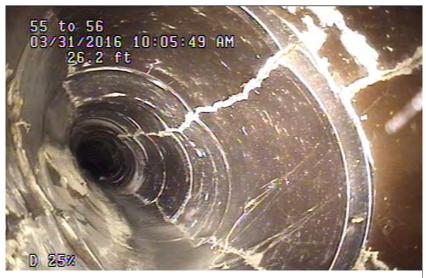
Video inspection shows the clay pipes under Green Street to be in poor condition. Several lines in this system are cracked and egged clay in need of repair. "Egging" is when pipes develop an egg like shape usually in response to pressure. Other factors contributing to the poor condition of the system include a concrete intrusion, a large hole in a pipe wall patched with a piece of metal, and a 10 inch gap between pipe segments. See Appendix C: Figures C8 and C9.

EXAMPLE OF EGGED CLAY PIPE COMMONLY FOUND ALONG CORRIDOR

- Inlet spacing should be limited to no more than ½ acre basin areas and longitudinal road grades should be reset to provide positive drainage along the curb line. Additional structures are needed.
- Existing clay pipe would need to be removed and replaced with current GDOT standard material, typically reinforced concrete pipe

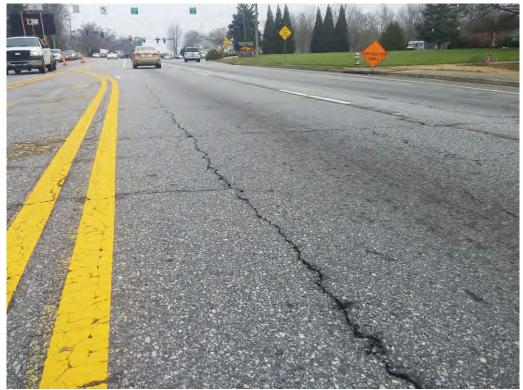
Load Cracking Level 1 – SR 11, Station 4 + 00, NB, Lane 1

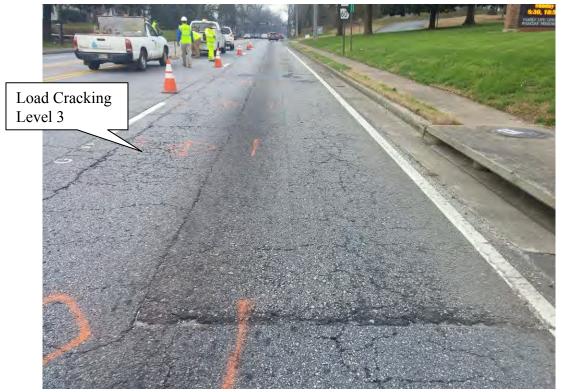
Raveling Associated with Load Cracking Level 3, at Station 4 + 00, SB, Lane 2

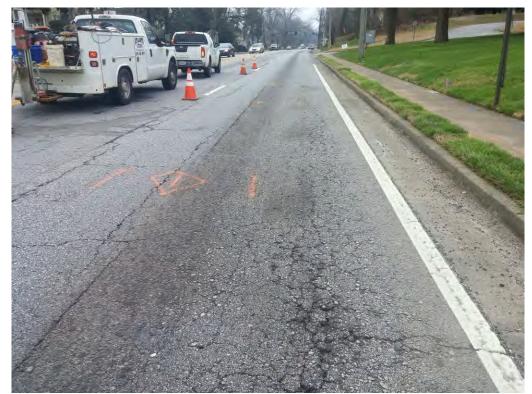
Load Cracking Level 3 – SR 11, Station 4 + 00, SB, Lane 2

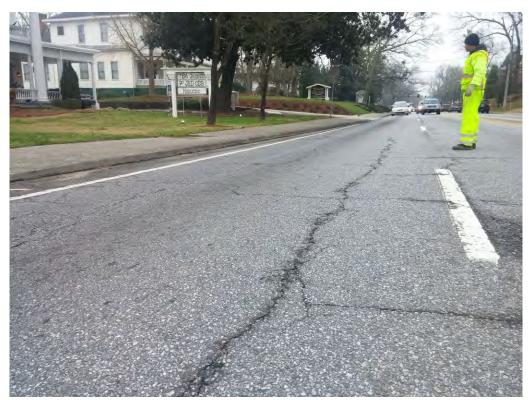
Load Cracking Level 1 – SR 11, Station 4 + 00, NB, Lane 2

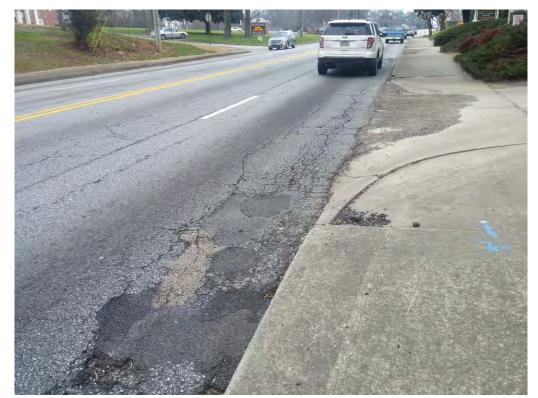
Patches associated with Load Cracking Level 3, SR 11, Station 7 + 00, NB, Lane 2

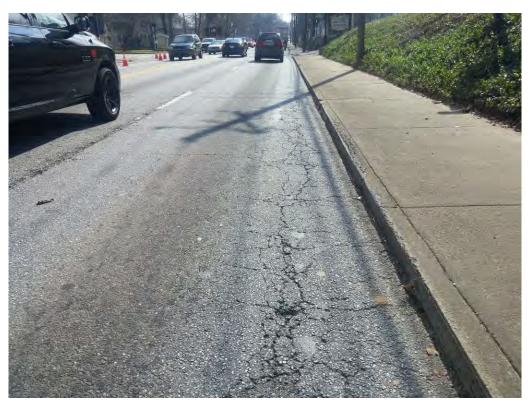
Load Cracking Level 3, SR 11, Station 9 + 00, SB, Lane 2

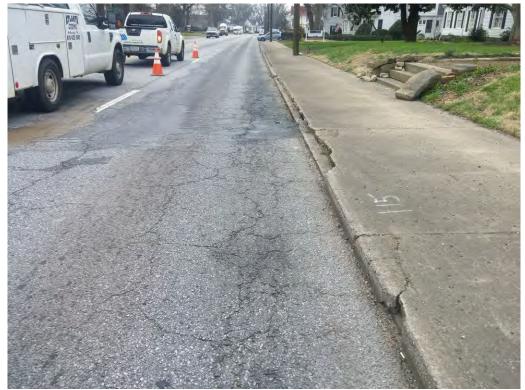
Load Cracking Level 3, SR 11, Station 15 + 00, SB, Lane 2

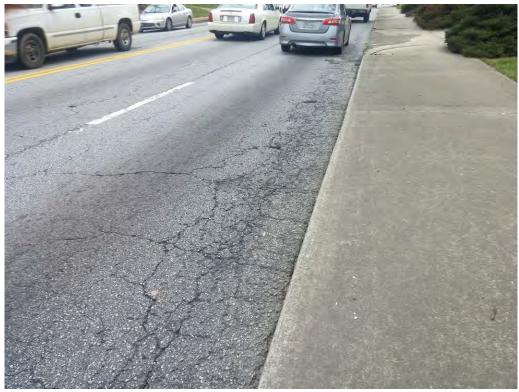
Load Cracking Level 4, SR 11, Station 18 + 00, SB, Lane 2

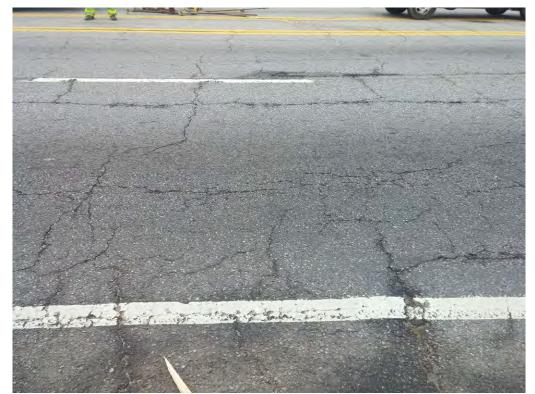
Block/ Transverse Distress Cracking Level 1, SR 11, Station 4 + 00, NB, Lane 2

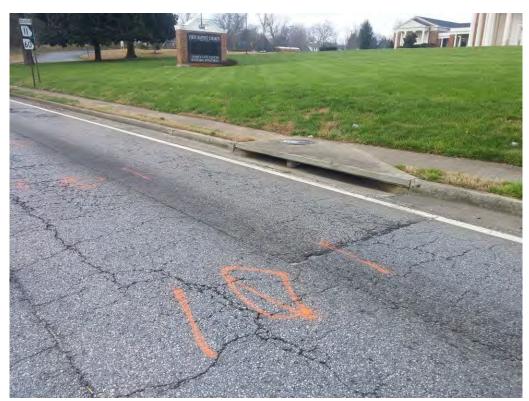
Block/ Transverse Cracking Level 2, SR 11, Station 4 + 00, SB, Lane 2

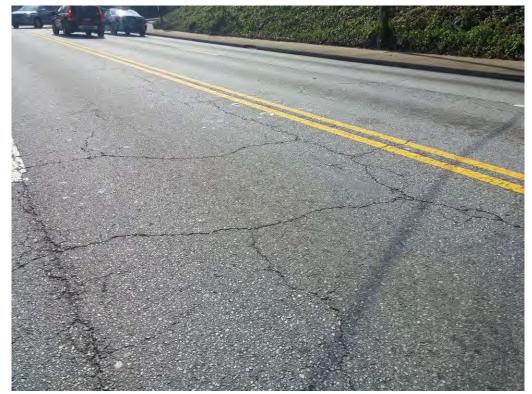
Block/ Transverse Cracking Level 2, SR 11, Station 9 + 00, NB, Lane 1

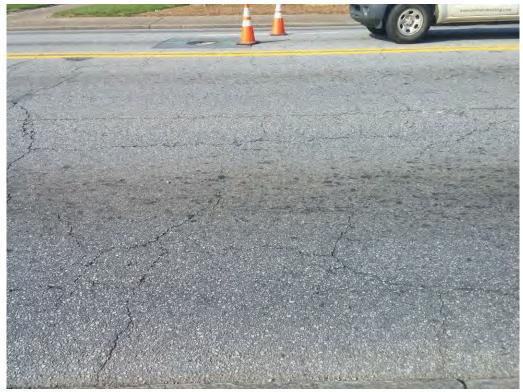
Block/ Transverse Cracking Level 1, SR 11, Station 15 + 00, NB, Lane 1

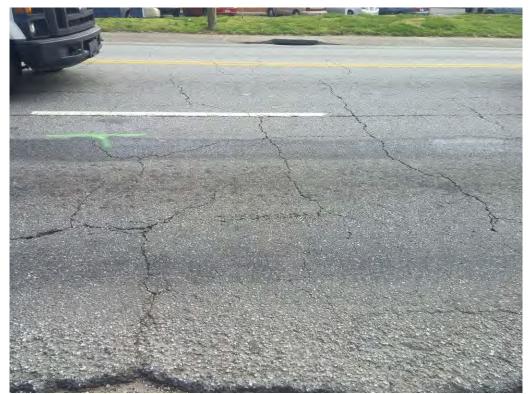
Block/ Transverse Cracking Level 2, SR 11, Station 15 + 00, SB, Lane 2

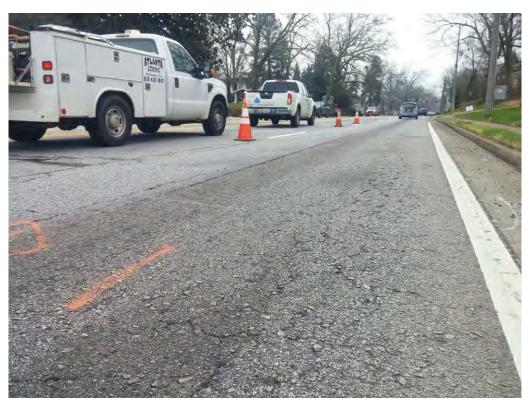
Raveling Level 2, SR 11, Station 4 + 00, SB, Lane 2

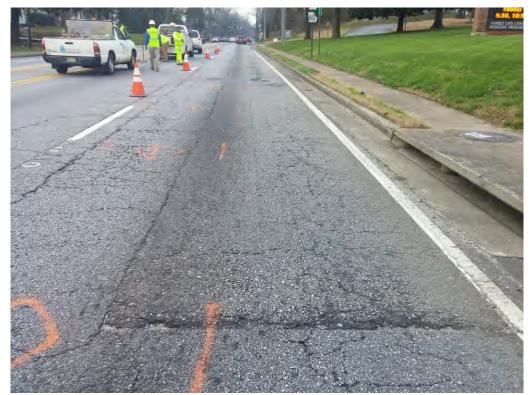
Patches from Station 3 + 00 to Station 4 + 00, SR 11, SB, Lane 2

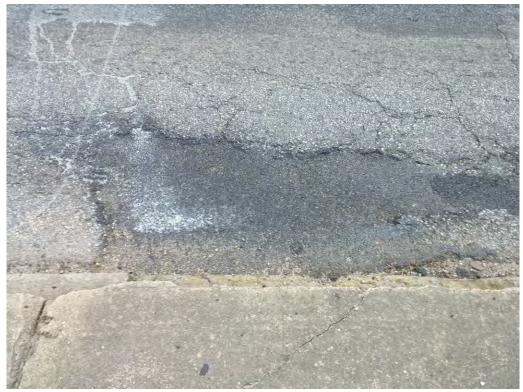
Potholes associated with Level 4 Load Cracking, Station 15 + 00, SB, Lane 2

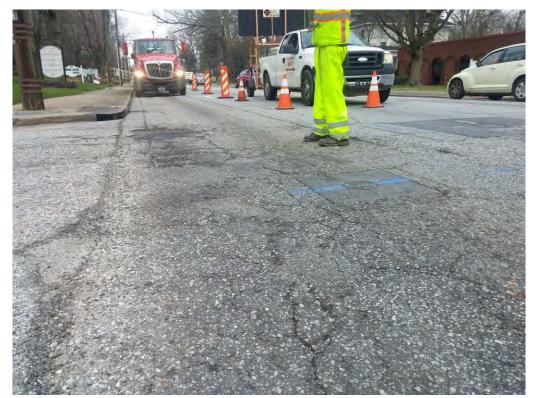
Raveling Level 2 and Load Cracking Level 4, SR 11, Station 15 + 00, SB, Lane 2

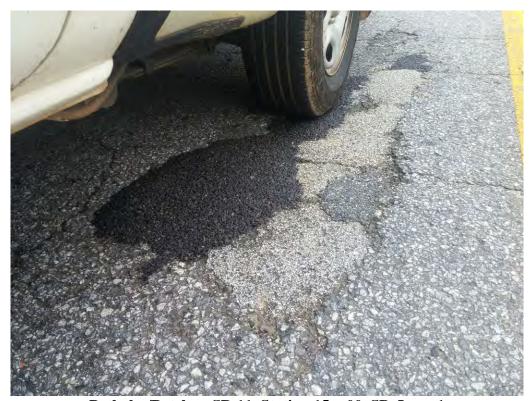
Potholes/Patches, SR 11, Station 15 + 00, SB, Lane 1

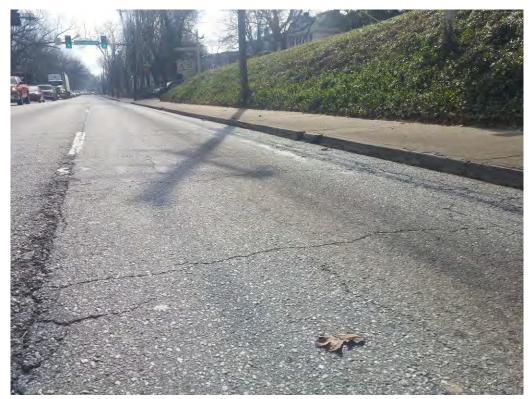
Raveling Level 1, SR 11, Station 9 + 00, SB, lane 2
