## Green Street Corridor Study May 2016

#### INTRODUCTION

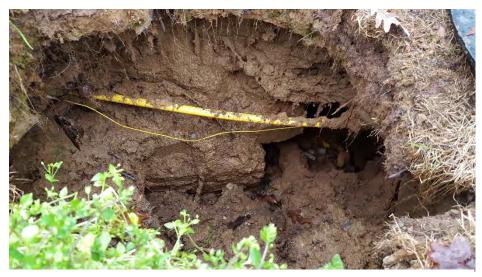
SINKHOLE NEAR GREEN STREET CIRCLE

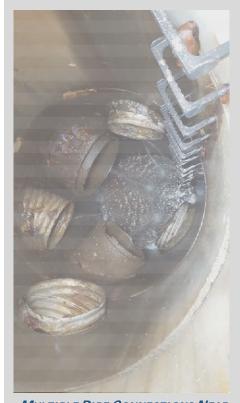
MULTIPLE PIPE CONNECTIONS NEAR **OUTFALL BEHIND THE TIMES** BUILDING

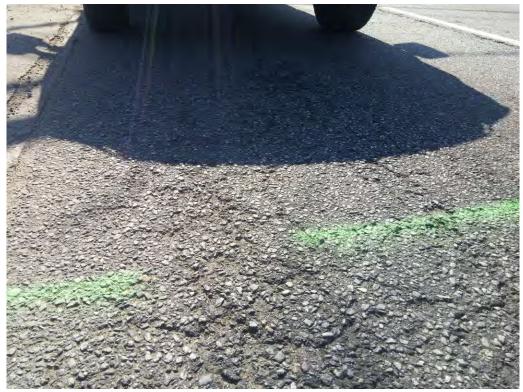
Raveling Level 1, SR 11, Station 9 + 00, SB, lane 2

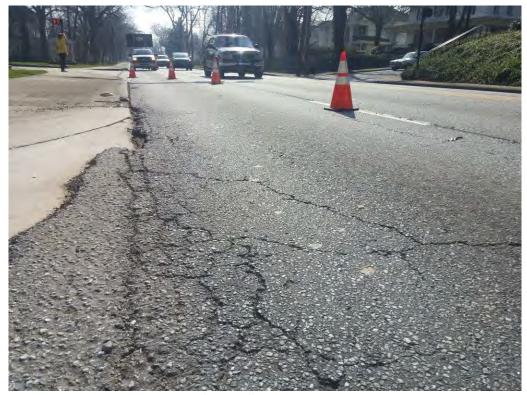
Raveling Level 2, SR 11, Station 26 + 00, SB, Lane 2

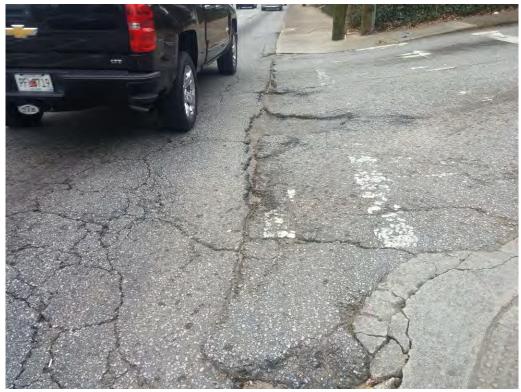
Edge Distress Level 3, SR 11, Station 9 + 00, Northbound, Lane 2

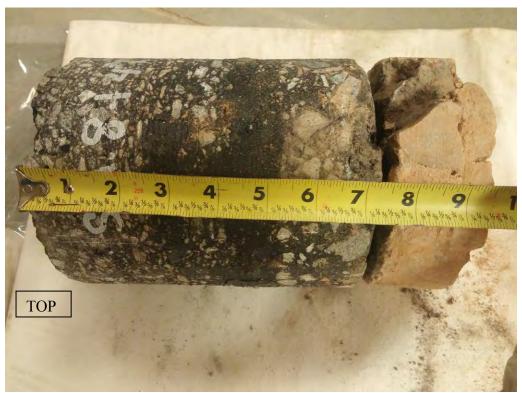
CORE 1 – GREEN STREET – STATION 3 + 56±, SB, LANE 1, 5.5' RT OF CL

- The station locations for Green Street were not provided or staked in the field by a surveyor. United Consulting determined the approximate location of these stations by using a measuring wheel from the intersection with Riverside Drive to the intersection with Academy Street and a hand-held Global Positioning System (GPS).
- Pavement cores at station 8+47 Northbound Lane 2 and Station 26+11 Southbound Lane 1 showed signs of bleeding. Therefore, deep patching or full depth replacement should be considered within these areas.
- Overlay construction are not acceptable in other areas that are not listed above. Based on the visual observation and the core recoveries, the existing roadway has suffered significant level 3 and level 4 load cracking. These cracks traverse through the existing pavement. Full Depth Replacement is recommended for these sections. See Core 1.
